**LOWER DRESSER NO. 4 DAM
WASHINGTON COUNTY, MISSOURI
MO 31123**

**PHASE I INSPECTION REPORT
NATIONAL DAM SAFETY PROGRAM**

PREPARED BY
INTERNATIONAL ENGINEERING COMPANY, INC.
CONSULTING ENGINEERS
SAN FRANCISCO, CALIFORNIA

JUNE 1979

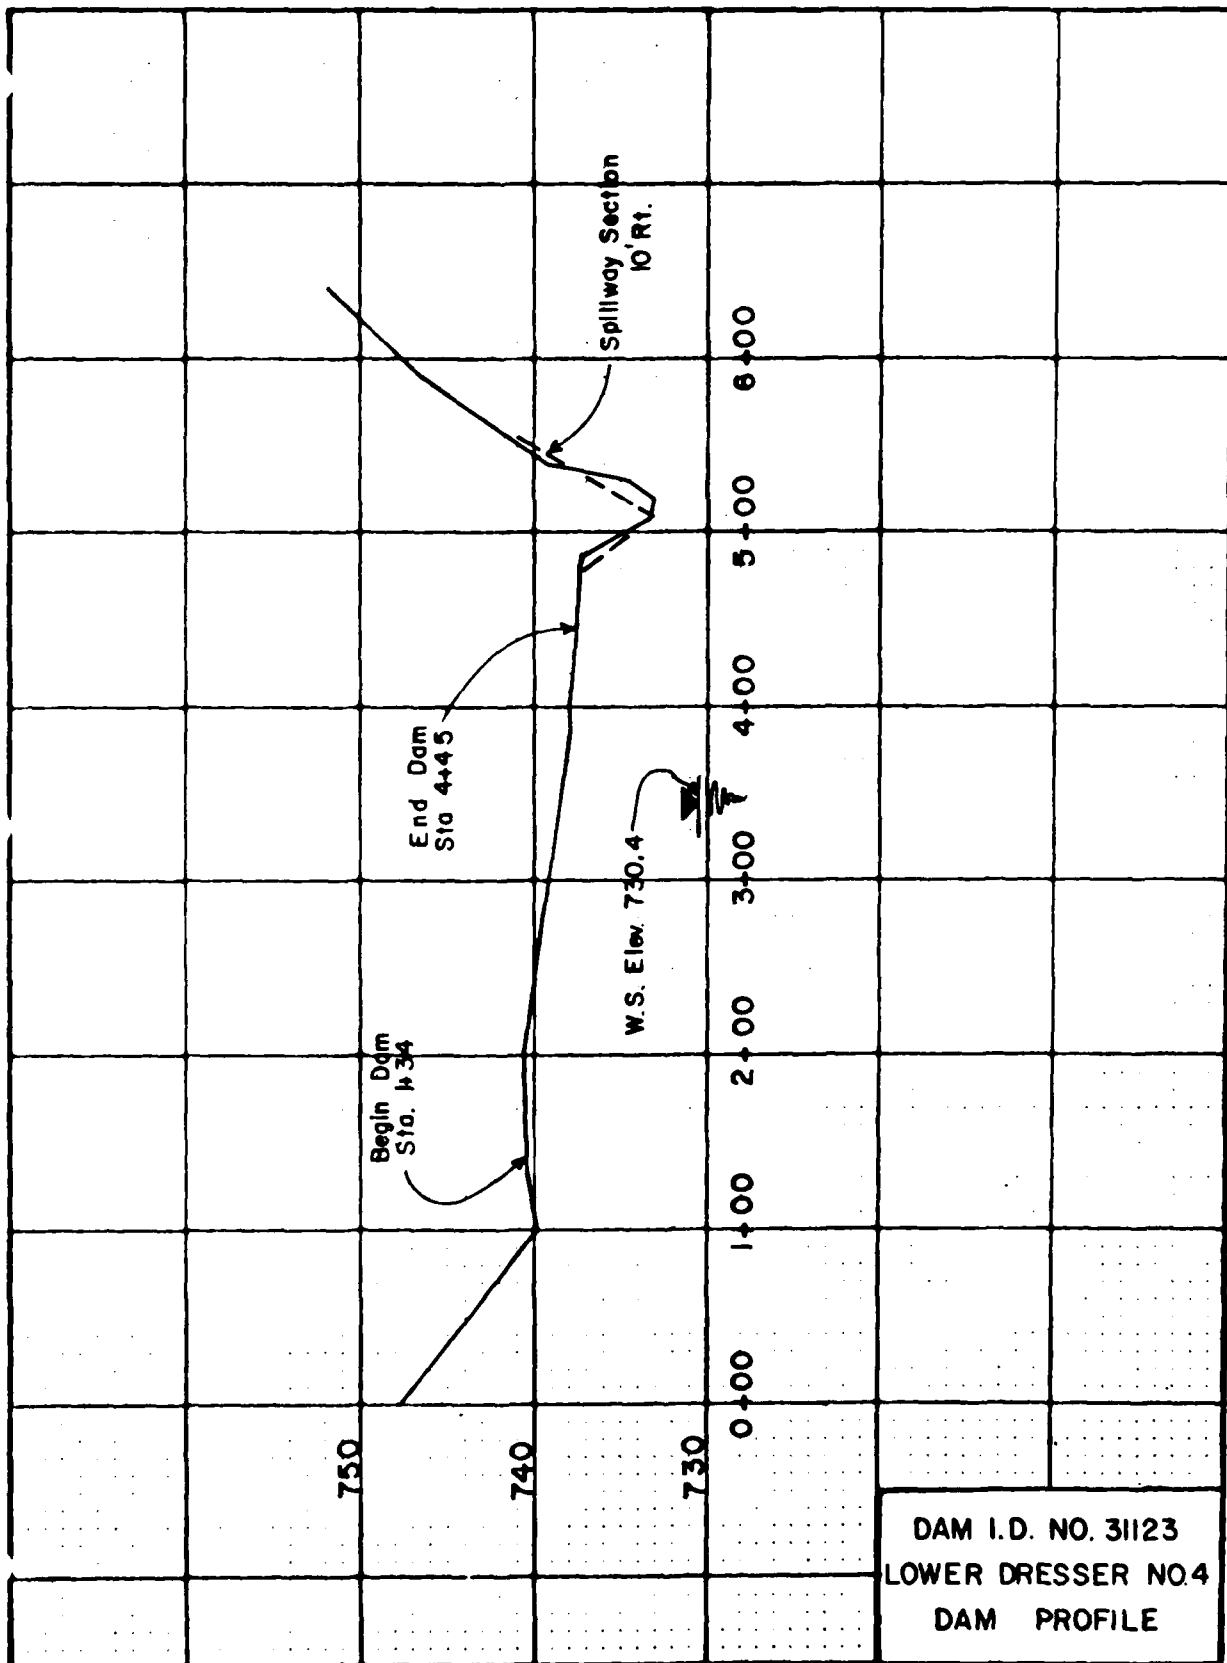
PLATE 3

Two springs were observed at the maximum section of the dam at the downstream toe. The springs are approximately 15 feet apart and are shown on the plan of the dam, Plate 3. At the time of the inspection, the flow from Spring No. 1 was estimated to be 15 to 25 gpm. Spring No. 2 was flowing at an estimated rate of about 5 gpm. The ground was firm at both springs. The flow from both springs was clear and there was no evidence of piping. Some vegetation and trees are growing in the channels where the springs emerge from the dam.
